Imaging Detects Cracks in Multilayer Ceramic Capacitors

The test program

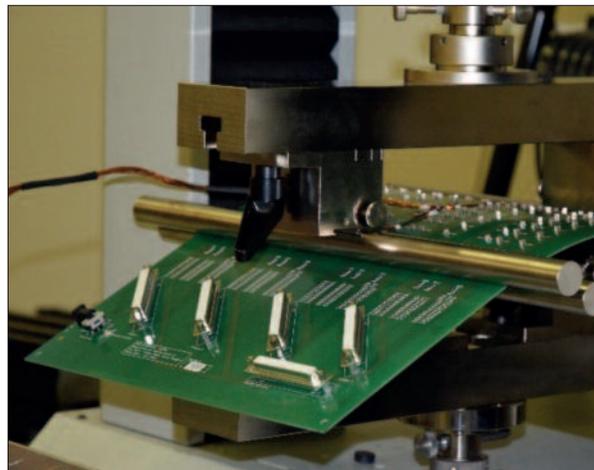
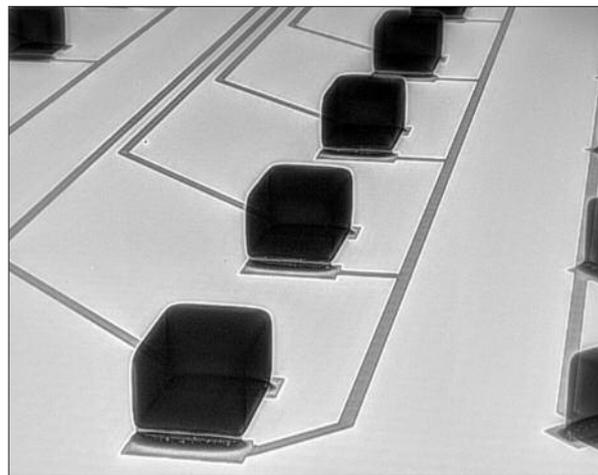
Figure 3: Overview 2D X-ray image showing several 1812-sized MLCCs placed parallel (0°) to the bending direction, where cracks in all five MLCCs can be seen

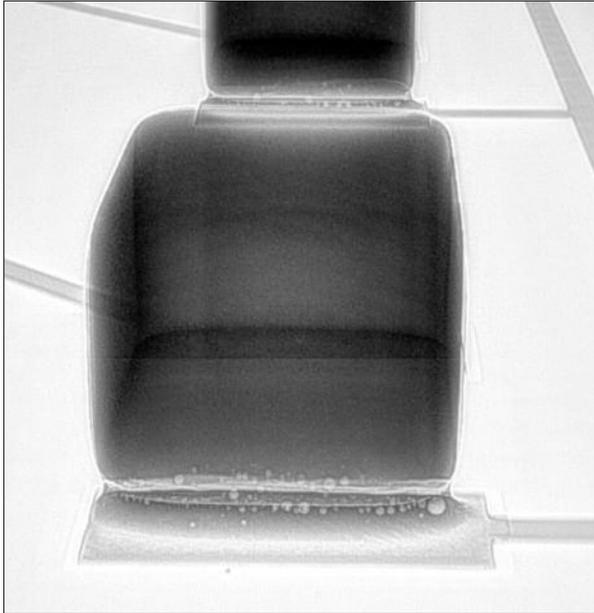
Figure 4: Magnified 2D X-ray image of an MLCC in which the crack is clearly visible

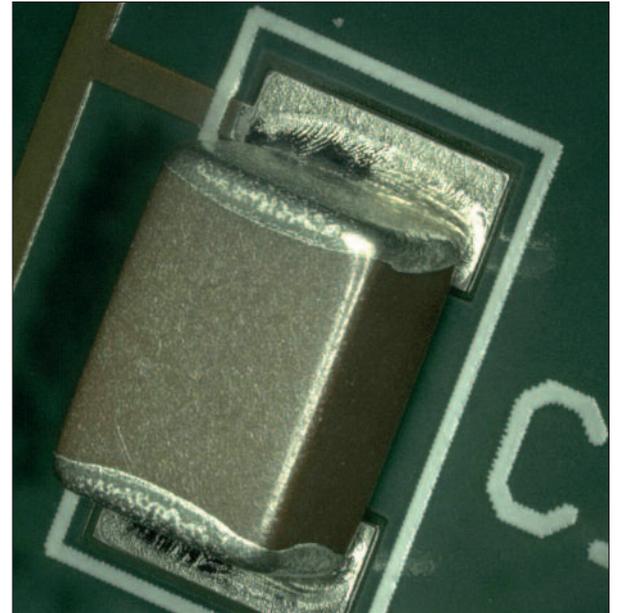
Figure 5: Optical microscopy image of the same MLCC showing no external sign of a crack

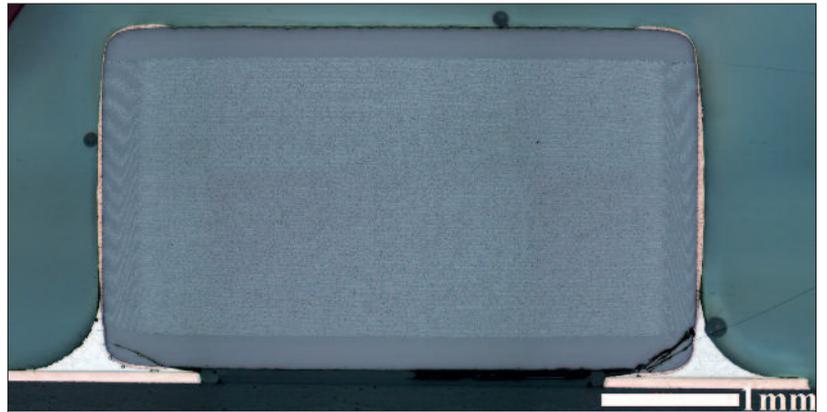
Figure 6: Cross-section of the MLCC shown in Figures 4 and 5, confirming the presence of a crack into the active electrode area

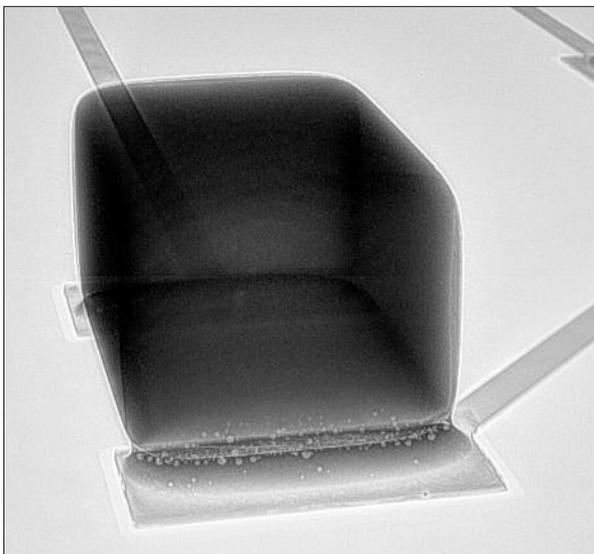
Figure 7: Zoomed in X-ray image of an MLCC mounted 45° to the bending direction. Several small cracks are identified especially in the magnified inset at the top

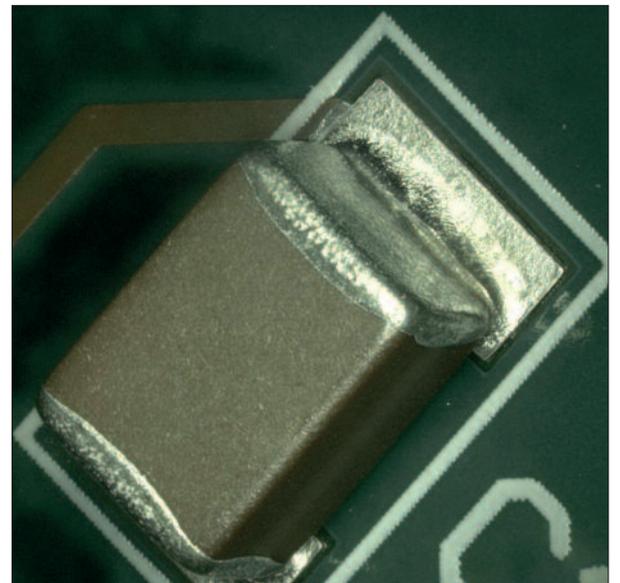
Figure 8: Optical microscopy image of the same MLCC as shown in Figure 7. No external sign of a crack can be observed

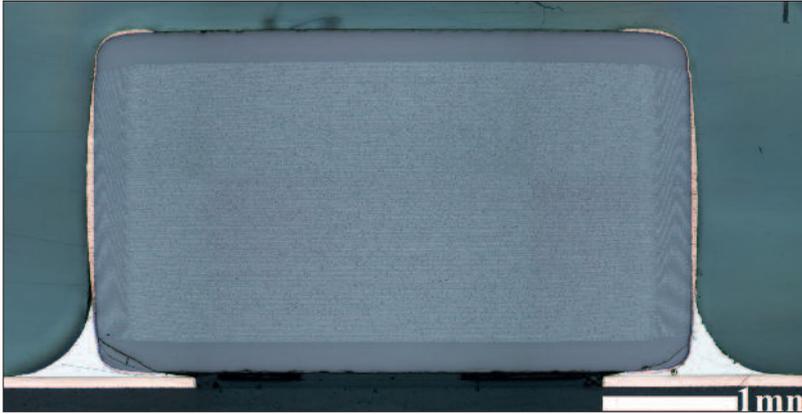
Figure 9: Cross-section of the MLCC shown in Figures 7 and 8, confirming the presence of a crack into the electrode area

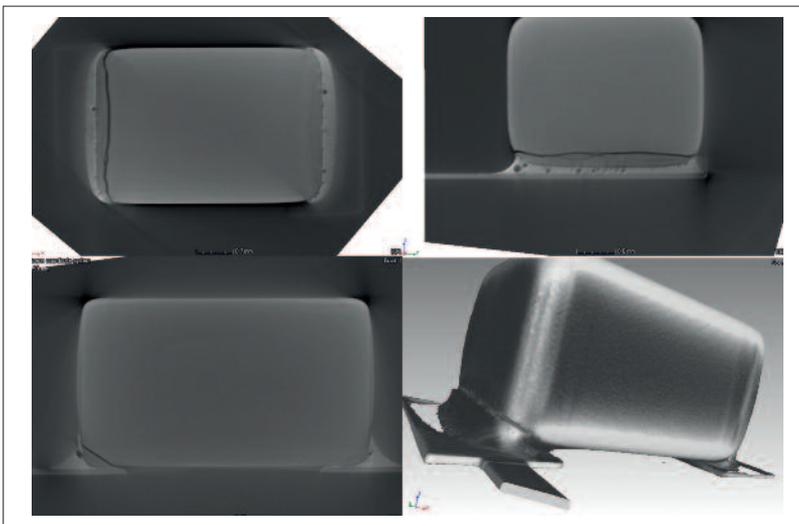
Figure 10: Non-destructive virtual 3D slicing images and 3D reconstruction of the cracked MLCC from Figures 4 to 6 for even better crack identification

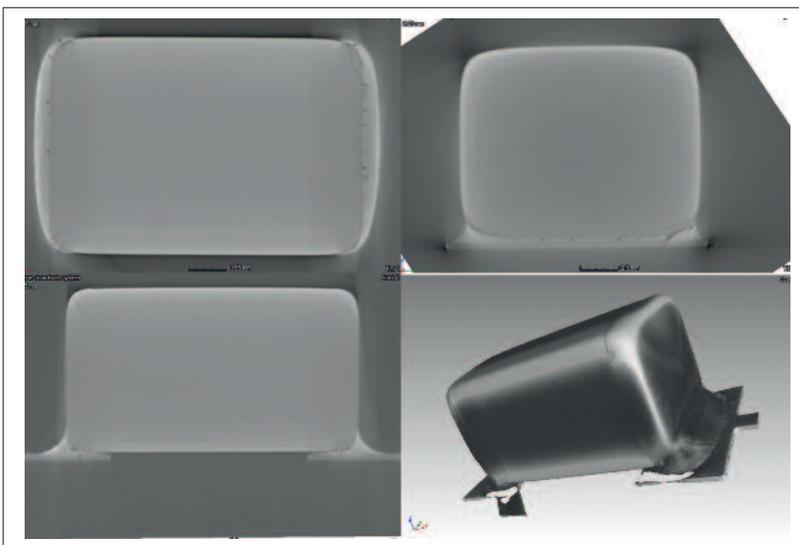
Figure 11: 3D CT X-ray images of the MLCC shown in Figures 7 to 9 showing a small and discontinuous crack

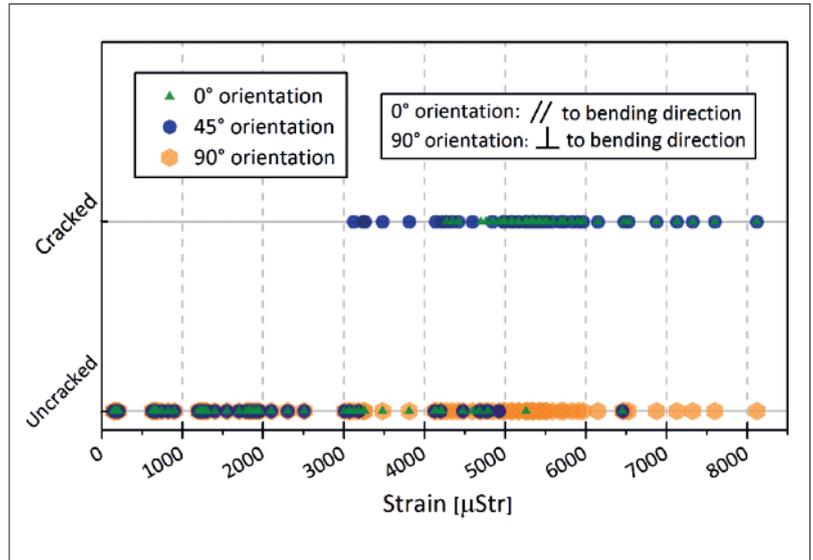
Figure 12: Indication of cracked or uncracked MLCCs for different strain levels and orientations

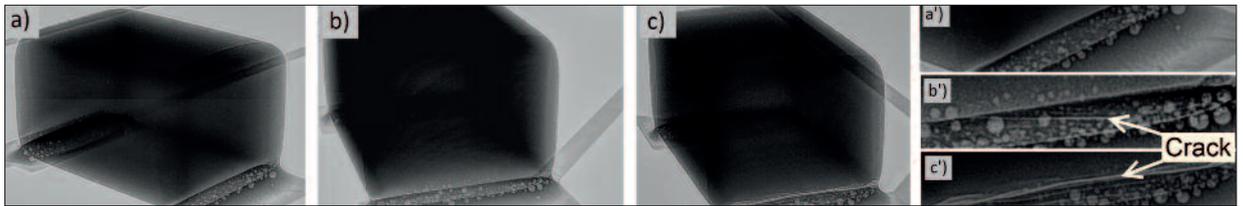
Figure 13: Cracks of different orientations
